Modelling of the HMAS Westralia Fire

DSTO-TR-0698

# MODELLING OF THE HMAS WESTRALIA FIRE

The HMAS Westralia fire incident of 5 May 1998, involved the combustion of a quantity of diesel fuel in the engine compartment. Four sailors were killed and the ship disabled.

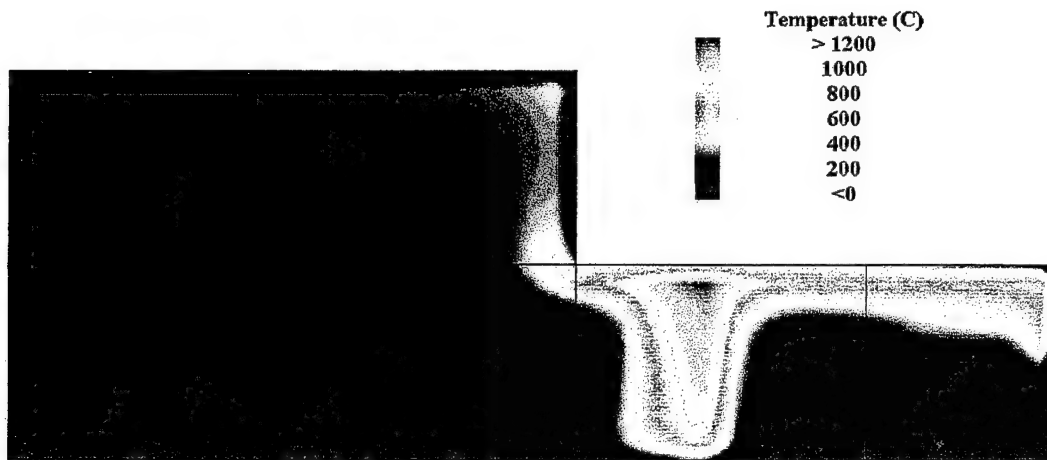
The starboard bulkhead adjacent to the fire source and the deckhead directly above the fire source (the deck of the MCR) were subjected to the most intense heat. Figure 6 depicts the predicted temperature distribution 1 minute into the model incident for a plane through the model along the starboard bulkhead adjacent to the starboard engine. Temperatures of greater than 1200°C are predicted near the top of the wall.

Figure 6. The temperature distribution of the fire incident on a section through the wall adjacent to the starboard engine is shown. Viewed from the starboard side. The thick black lines indicate the positions of the lower and upper mezzanine floors.

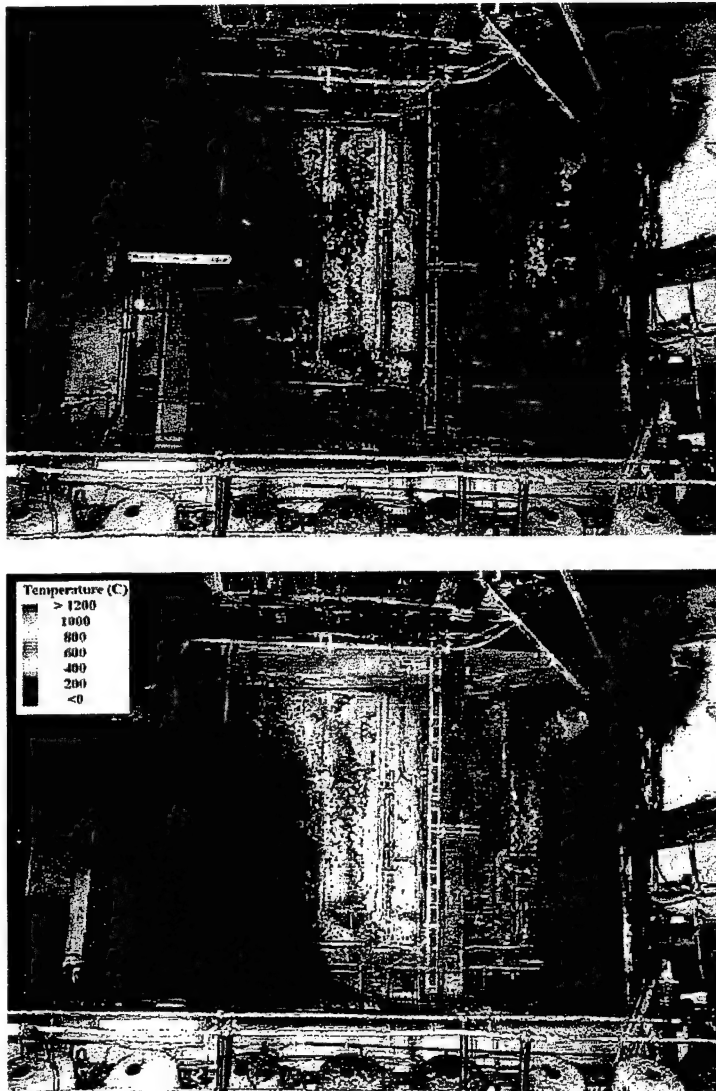
The damage observed on the starboard bulkhead can be compared with the predicted temperature distribution. In figure 7, the first picture shows a view of the bulkhead taken from the port side lower platform and the second has the FLOW3D temperature distribution at 1 minute superimposed on it. The shape and size of the temperature distribution matches well with the shape the size of the damaged area. In the modelled scenario the fuel is cut off after 1 minute which results in the temperature distribution on the wall being at its maximum. For the real fire, the damage to the wall is in effect a snapshot of the maximum temperature.

The paint blister line drawn in figure 3 matches well the line corresponding to the transition from purple to blue (150°C) in figure 7. The line marking the transition from blackened paint to a whitish residue matches the green (450-500°C). Both give confidence in the assumptions made in creating the model.

Two aluminium light fittings were attached to the starboard wall 2.5m above the level of the top of the engines. The aft fitting can be seen in the top image of Figure 7 to be reduced to a steel bracket. As seen in the lower image of Figure 7, the model predicted this fitting to be exposed to temperatures of 600 to 800°C (green-yellow). Aluminium melts at near 660°C. The forward fitting can be seen in the top image of Figure 7 to be reduced the aluminum backing and bracket. The polycarbonate diffuser and the plastic fittings have melted away completely and the tube has fallen away. The model results predict a temperature of near 150°C (purple-blue) consistent with the damage observed.

Figure 7. A comparison of the fire damage can be made with the maximum temperature distribution predicted by FLOW3D. The top picture shown the starboard wall adjacent to the fire source and the lower picture shows the FLOW3D temperature distribution predicted at the wall.

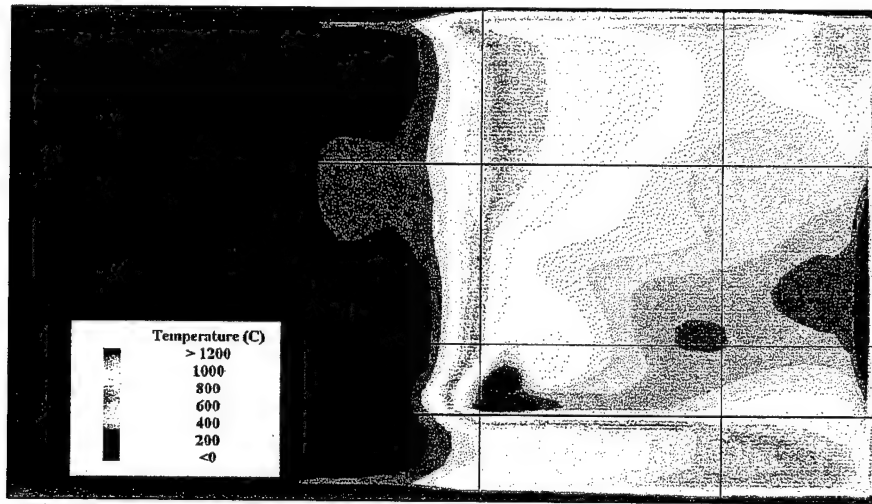
The temperature distribution under the MCR is of interest since this is where significant damage was done to the cabelling and the 3 tonne lifting rail directly above the fire source. Very high temperatures are indicated in the region of the cables ( $>1200^{\circ}\text{C}$ ) and in the area above the cargo pumps. The temperature distribution predicted for a horizontal plane 0.5 m below the MCR floor is shown in Figure 8. The

Figure 8. The temperature distribution is shown, viewed from above, 0.5 metres below the MCR 1 minute into the event. A fireball is predicted to have spread across the whole of the underside of the MCR. The hottest spot is directly above the fire source. The wall adjacent to the starboard engine can be seen to effectively block the heat getting to the machinery behind it.

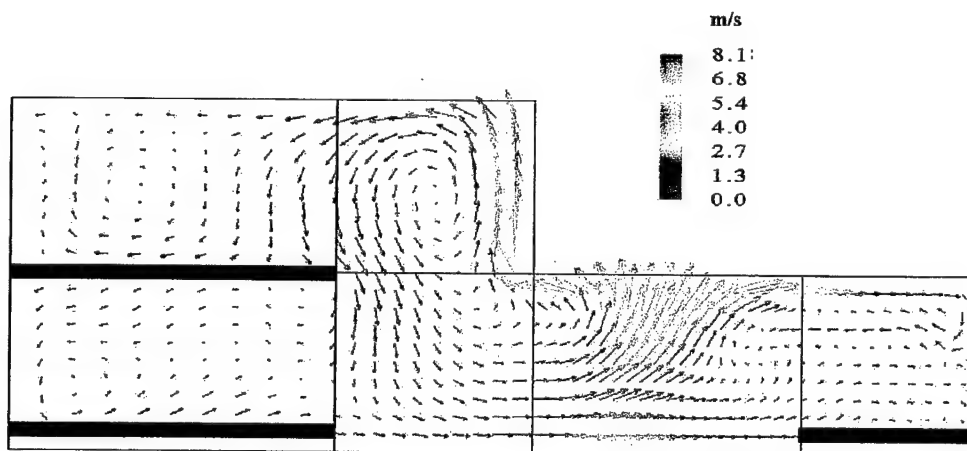
Figure 9. The bulk airflow of the compartment is depicted 1 minute into the incident for a aft-forward vertical section through the fire source. The main area of concern is the flow above the cargo pumps where hot gases are directed down onto the top of the motors.

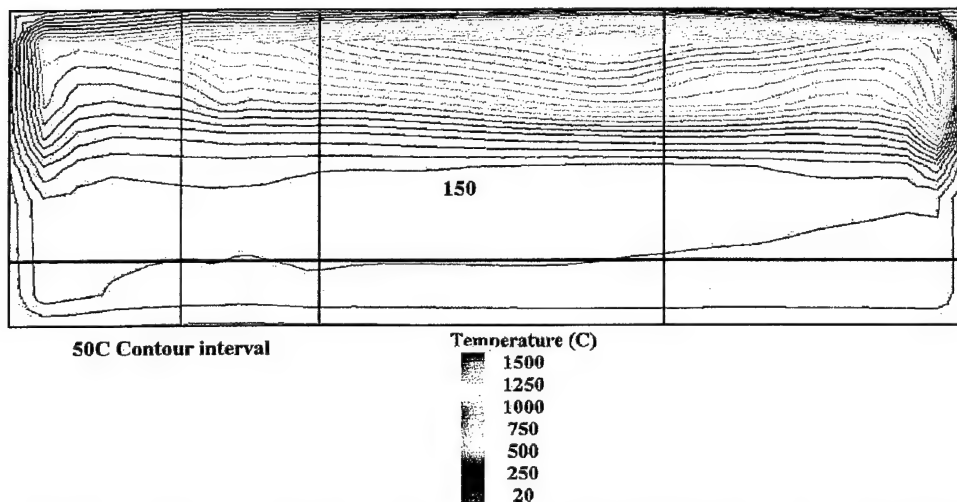
The exposure of the cargo pumps to high temperatures is of concern to the cost of repairs to the vessel. The predicted temperature contours is shown in Figure 10 for a section across the compartment through the location of the cargo pumps.

The 150 C isotherm is labeled and is significant as at this height the adhesive label was obtained from cargo pump number 3. A contour interval of 50°C was used in drawing the figure.

Figure 10. The isotherm predictions are shown, 1 minute into the incident, for a section through the cargo pumps area. The view is toward aft. Temperatures as high as 500C are predicted of the air at the tops of the pumps. The 150°C contour corresponds to the position of an adhesive label attached to the pump. An examination of a sample of this label suggests an exposure to a temperature of approximately 140°C.

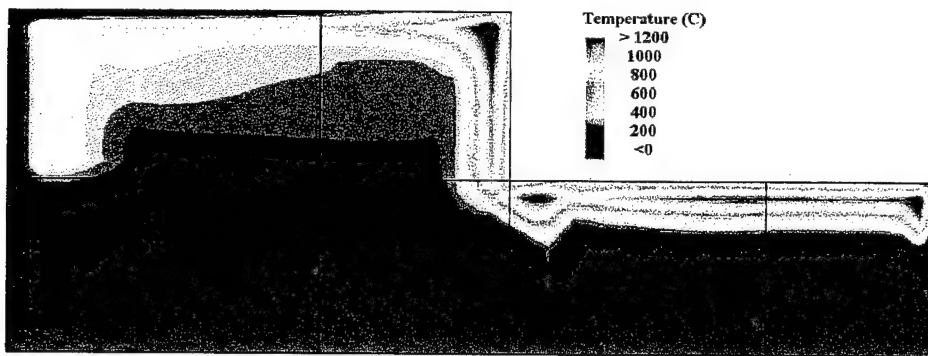
The flow of heat to the diesel generators is also of some concern. Figure 11 shows the predicted temperature distribution of the fire incident after 1 minute. The figure shows an aft to forward section through the origin of the fire. The bottom of the picture corresponds to the top of the starboard engine. The temperatures in the area of the diesel generators remain near ambient. However the area near the cargo pumps at the forward bulkhead are subjected to significant heat loading at levels corresponding to the top of the pumps.

Figure 11 shows the predicted temperature distribution of the fire incident after 1 minute. The figure shows an aft to forward section through the origin of the fire. The bottom of the picture corresponds to the top of the starboard engine.

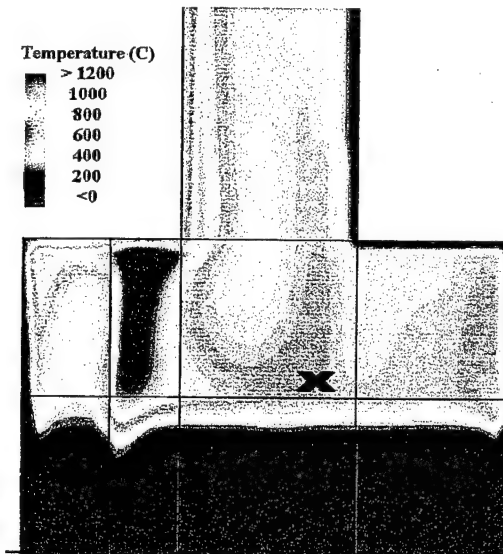
The model temperature predictions for the section just aft of the MCR looking aft are shown in Figure 12. The hot plume spilt from under the MCR can be seen to rise up the starboard side. Predicted temperatures of approximately 500 to 600°C would be experienced at the MCR level near the starboard escape ladder (marked with an X). This is consistent with the damage to the aluminium walkway, which softened and buckled during the incident. The top of the port escape ladder (marked with an X) also was predicted to be exposed to temperatures of 300 to 400°C, again consistent with the damage observed (paint blistered and burnt, light fitting difusers melted and signs damaged).

Figure 12. Temperature distribution 1 minute into the event for a cut across the compartment aft of the MCR looking aft. High temperatures of the order of 400°C are predicted to exist at the top of the port ladder (marked with an X).

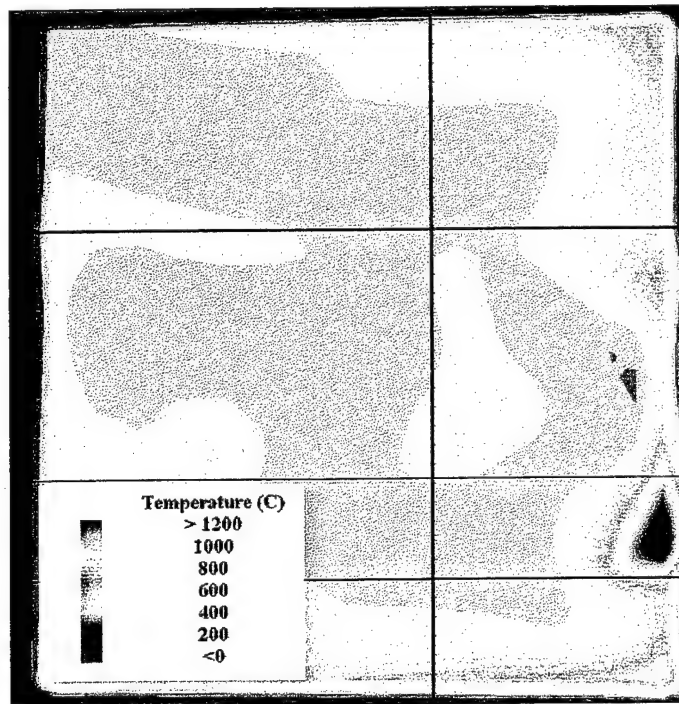
The firefighting team, from the level of the fridge flat, attempted re-entry into the engine compartment. This level refers to the top platform at the aft end of the compartment. The platform can be seen in Figure 2 just above the boiler. The predicted temperatures on the fridge flat level, depicted in Figure 13, one minute into the incident indicate that there is significant heating across the whole of this area. Temperatures are predicted to be near 350°C. The predicted temperature four minutes into the event is shown in Figure 14. Temperatures are predicted to have fallen to 100°C. At four minutes, this is still too hot for an attempted reentry [9]. The observed damage at the fridge flat level is again consistent with the predicted temperature history (light fittings melted and little damage to paint work)

Figure 13. The temperature distribution one-minute into the fire incident at the level of the fridge flat.

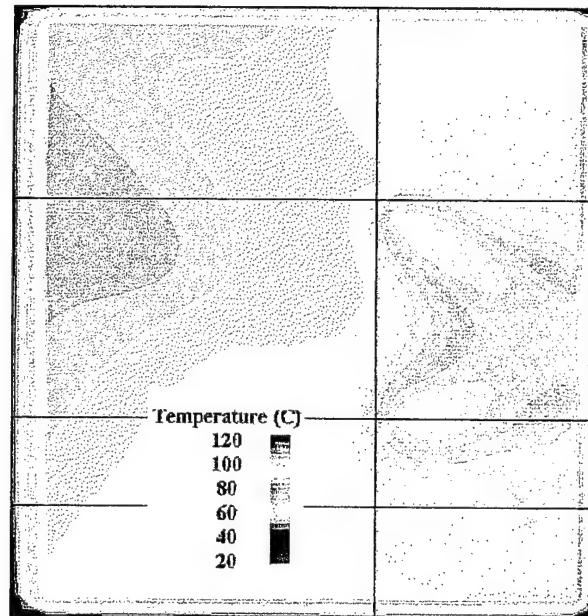
Figure 14. The temperature distribution is depicted 4 minutes into the fire incident at the level of the fridge flat. The residual temperatures at the aft end of the compartment, where the fire fighters attempted to re-enter the compartment, is still near 100°C and too hot for a reentry.

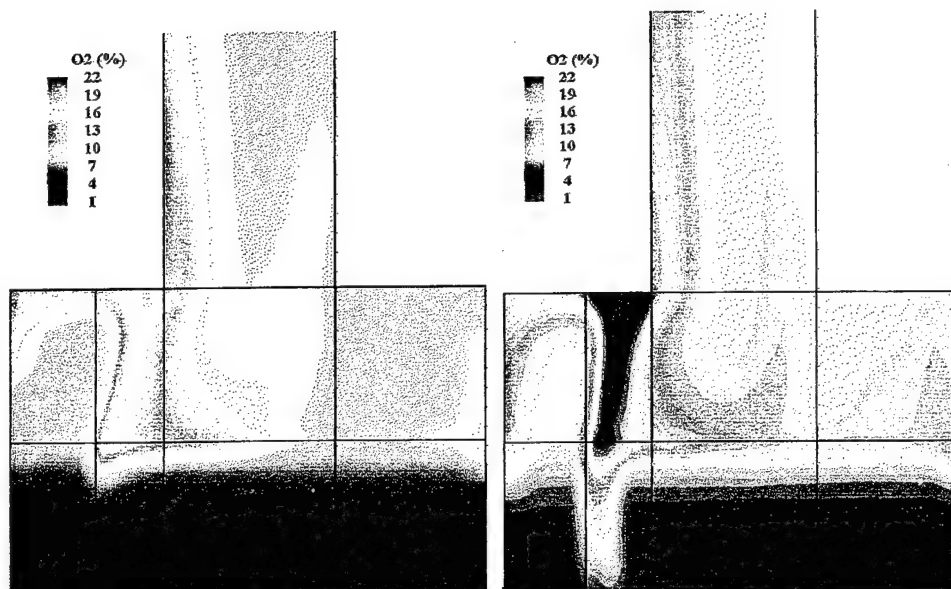
The oxygen content of the compartment is shown in Figure 15 for a section across the compartment just aft of the MCR looking aft at 30 and 60 seconds into the fire. The starboard side shows the depleted air associated with the fire plume rising rapidly up the starboard side of the stack. The port side shows a depleted oxygen level within a minute as smoke fills the whole compartment. The carbon dioxide level in the model, shown in Figure 16, has filled the compartment with levels of up to 10% CO<sub>2</sub> down below the MCR within a minute. The CO<sub>2</sub> distribution matches the oxygen loss distribution well indicating that in the model fire the fire was well ventilated.

Figure 15. Calculated oxygen content 0.5 minute and 1 minute into the fire incident. A cut across the compartment aft of the MCR is shown looking aft. The bottom of the picture corresponds to the level at the top of the engines. The horizontal line in the middle of the picture is at the level of the MCR. Low concentrations of oxygen are predicted at the top of the escape ladder

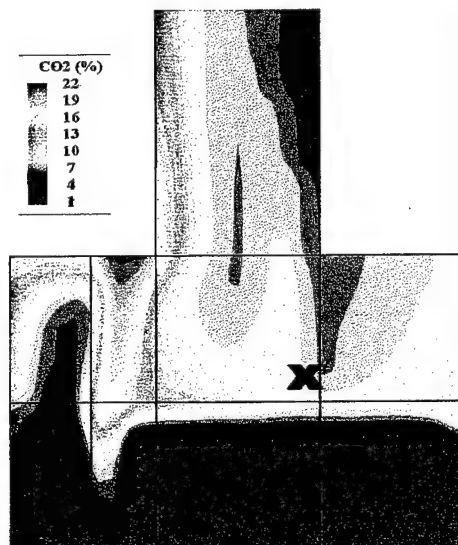
Figure 16 Calculated carbon dioxide levels 1 minute into the fire incident. A cut across the compartment aft of the MCR is shown looking aft with the same geometry as in Figure 15. High concentrations of  $\text{CO}_2$  are predicted at the top of the port escape ladder at the level of the MCR, (marked with an X).
